Waterco Case Study | Birdworld Farnham

Waterco filtration solves 'tricky' issue

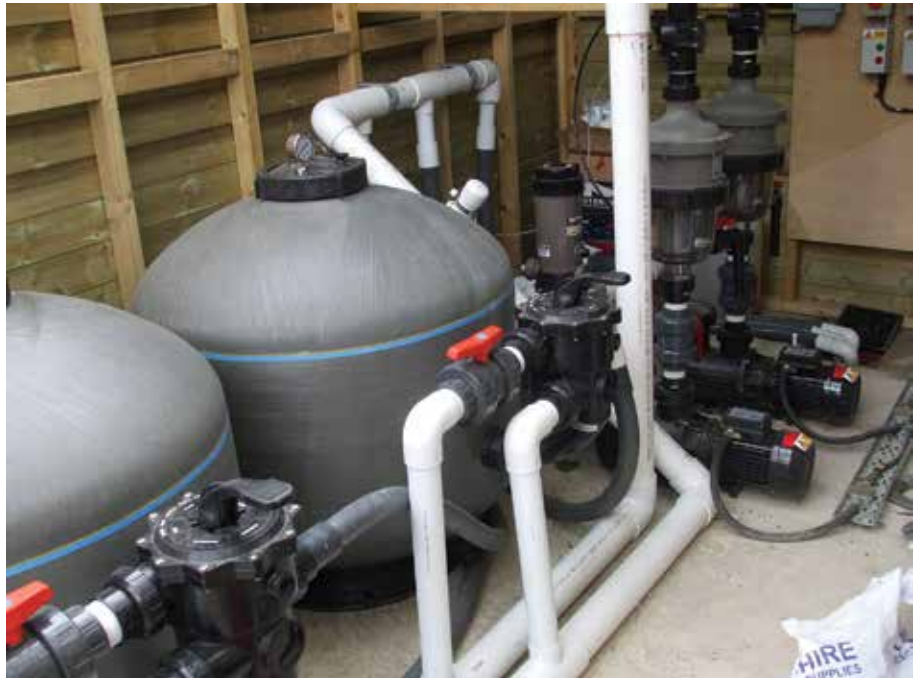
► Water is fed via two MultiCyclones and for extra clarity, the water was also fed through SM900 fibreglass filters filled with glass.

“We also installed Waterco non-return valves at water level to help with priming, as the plant room was higher than the pool. The water was then fed via two MultiCyclones to remove debris from rock and gravel.”

For extra clarity, the water was also fed through SM900 fibreglass filters filled with glass media, and then chlorinated with an erosion feeder before being returned to the pool. This solved the issue of poor water quality that was presented by the large amount of gravel in the water.
